WINDOW RUBBER REPLACEMENT

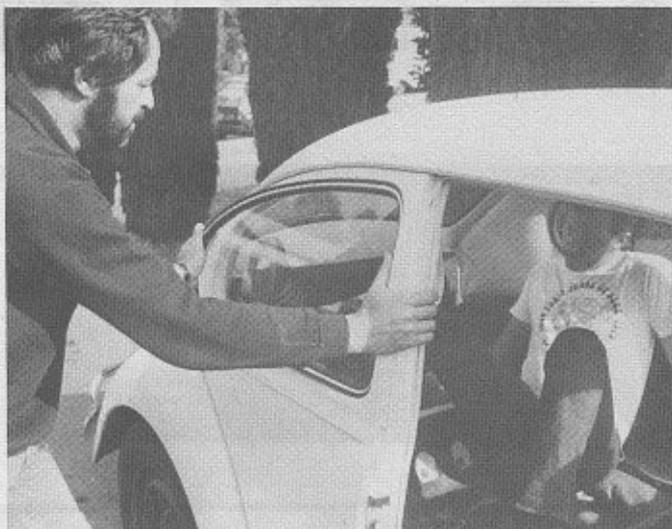
STEP 1, involves pushing the window out with the help of a foot. Bob Raucher, President of The Old Volks Home holds the glass while his right hand man, Cliff Crate pushes.

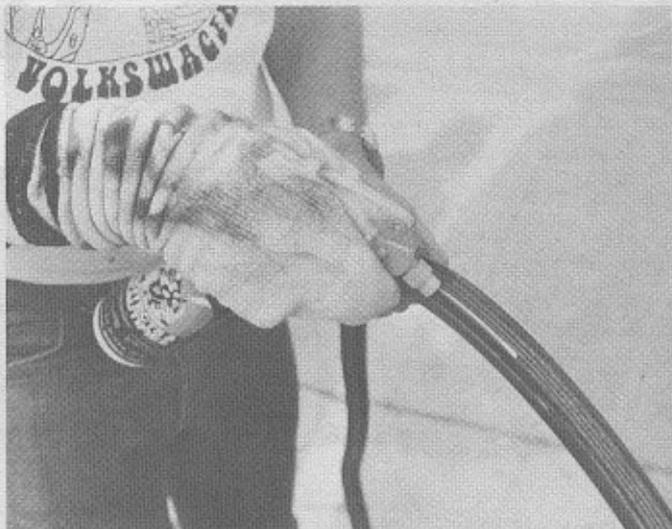
STEP 2, liberally coat the new rubber with Armor All, or a similar rubber lubricant. This helps keep the rubber alive longer as well as making the installation easier.

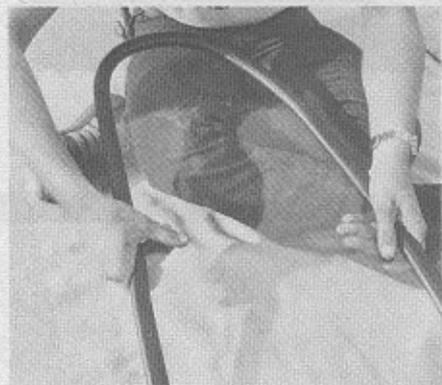
STEP 3, place the new window rubber onto the glass, making sure it is on the correct way and in the correct groove.

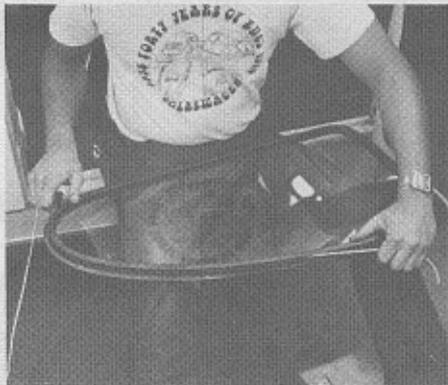
STEP 4, slip a long piece of strong, thin string around the window rubber, in the groove that will hold the glass in the window frame.

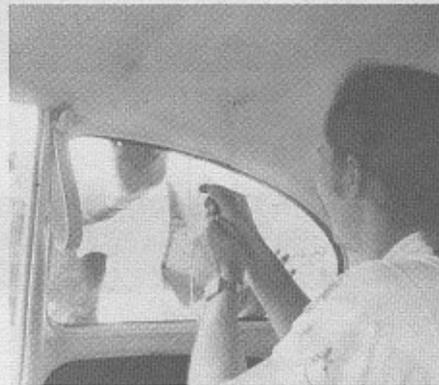
STEP 5, the window, with rubber attached, is placed in position in the window opening and the string is pulled from the inside.

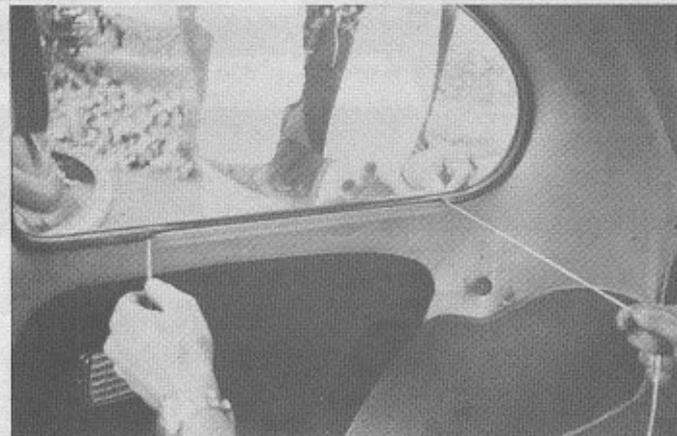
STEP 6, as the person inside pulls the string gently, the window is pushed into place from the outside. Make sure that the rubber gasket is pulled evenly over the bodywork. The most difficult spots are the corners and the bottom where the two strings meet. If the string pulls out without the rubber slipping into place, the whole process has to be restarted.

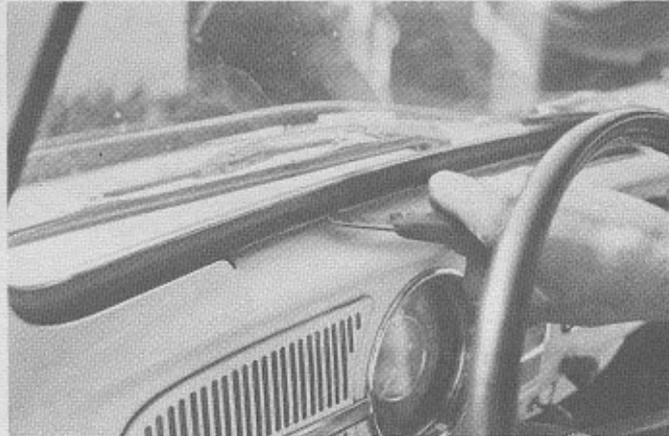
ABOVE, the preceding six steps show how the two side windows are replaced in a Bug. The rear window is done in the same manner, though it is a little more difficult because of being bigger. The front windshield, however, has to be treated much more carefully as it is weaker. To begin with, the old rubber gasket has to be cut away with a knife so that the windshield can be lifted out without force. Replacing it is done in much the same way, but far more carefully.
